RE: Weight Limit Restrictions on Hartson Slough Bridge 7C- 40, Mapes Road

Bridge Number : 07C0040
Facility Carried: CR 305 (MAPES RD)
Location : 0.4 MI E/O RD 303
City :
Inspection Date : 08/11/2020

Bridge Inspection Report

STRUCTURE NAME: HARTSON SLOUGH

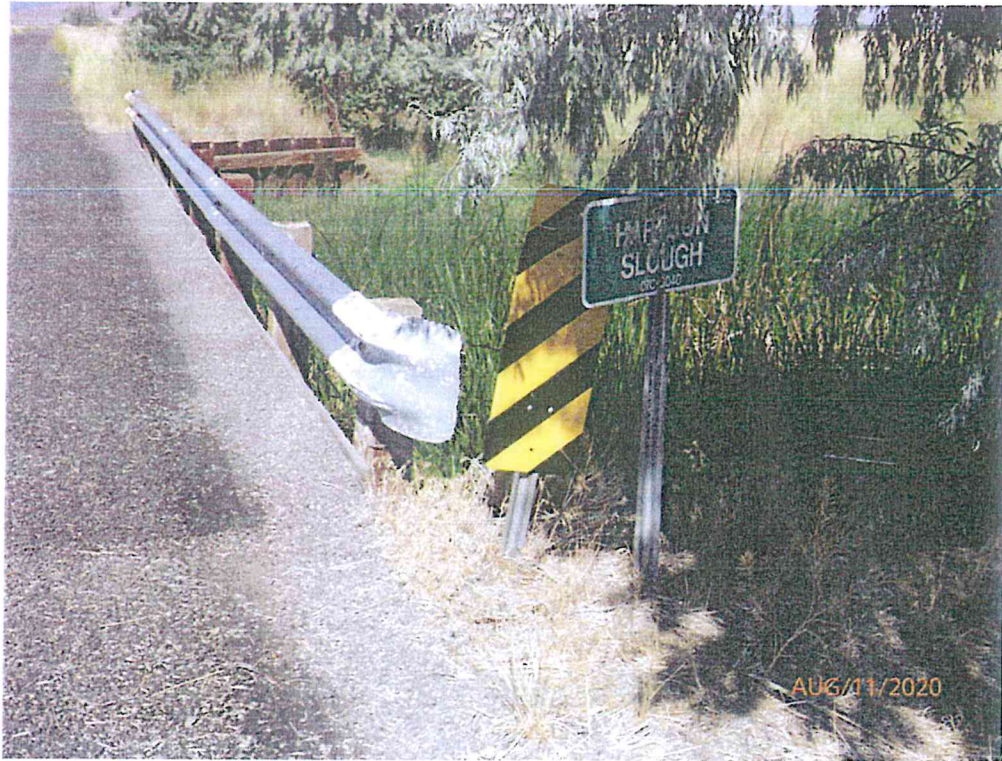
Photo No. 1

Type P object markers were present at the right side of Abutment 1 and the left side of Abutment 3 at the ends of the bridge rails. The object markers were partially obscured by the bridge identification signs and vegetation. Refer to photograph 1.

Object marker Abutment 3 left side - Looking northwest

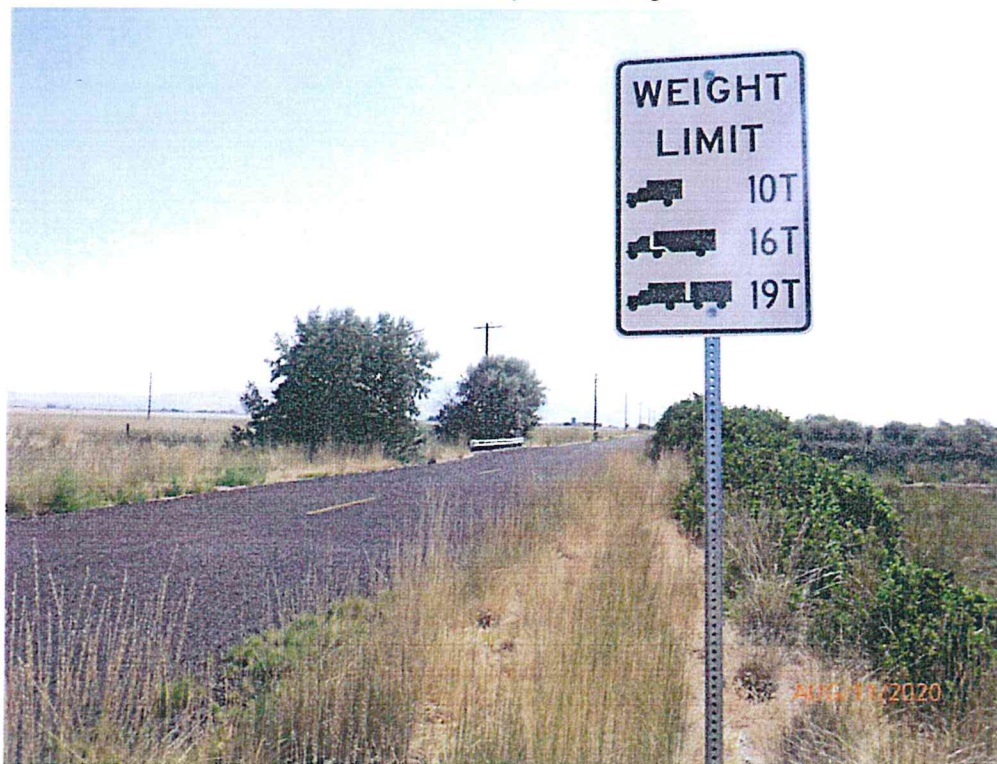
Photo No. 2

Regulatory signs restricting loads were present along the roadway approaching both abutments that indicate:

WEIGHT LIMIT

10 TONS PER VEHICLE

16 TONS PER SEMI-TRAILER COMBINATION

19 TONS PER TRUCK AND FULL TRAILER

Regulatory sign - Abutment 1 - Looking east

RECOMMENDED POSTING

Post the bridge for loads as follows:

14 TONS PER VEHICLE

23 TONS PER SEMI-TRAILER COMBINATION

28 TONS PER TRUCK AND FULL TRAILER

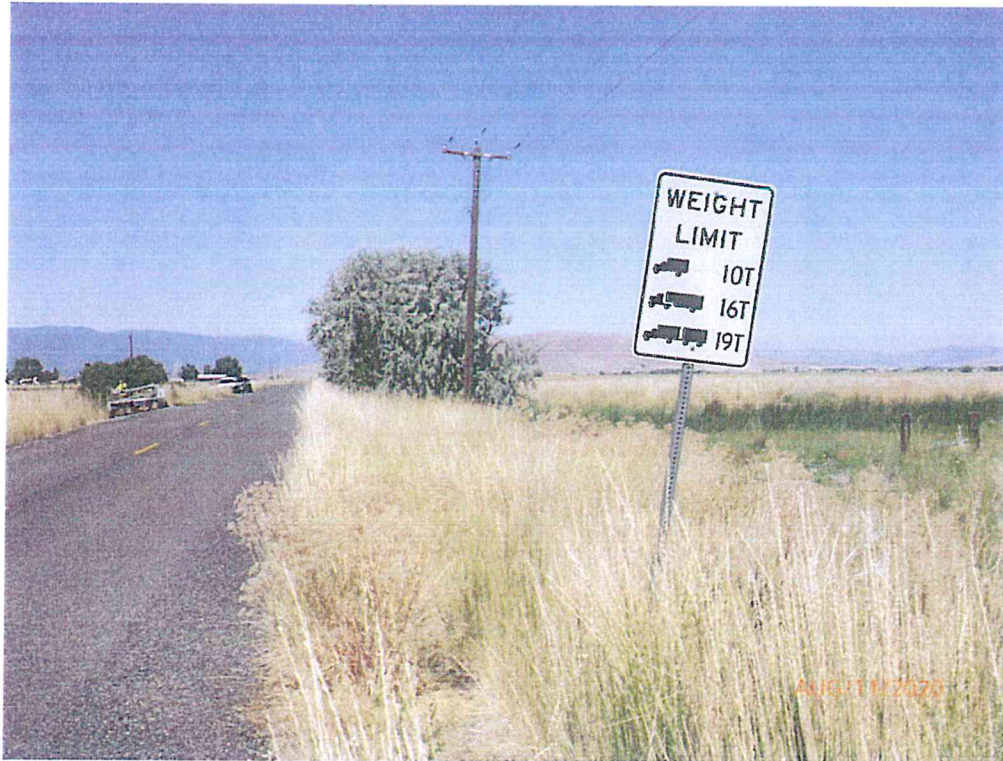
Photo No. 3

Regulatory sign - Abutment 3 - Looking west

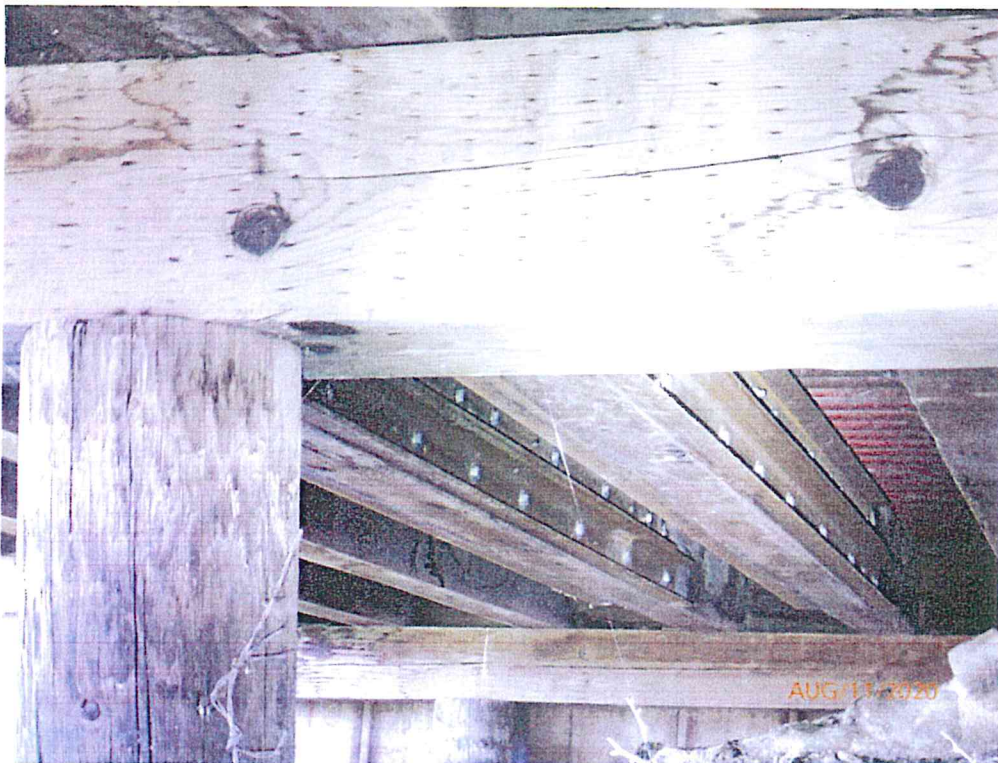
Photo No. 4

The 2007 inspection noted failure of Girders 4 and 5 in Span 2. The girders split diagonally along the girders. The splits were approximately 0.75 inch in width and 6 feet in length and located near midspan.

Prior to the 2015 inspection, timber Girders 4 and 5 in Span 2 were supplemented with steel channels. Two channels were placed on each side of each girder, totaling 8 channels. The channels were connected to the timber girder and to other channels by bolts through the timber girders. The channels were present along the majority of the span but did not extend to the supports. The vertical sides of the timber girders were obscured by the channels. During the 2015 inspection, the dimensions of the steel members were measured as follows:

Since the 2015 inspection report and within this inspection, the steel channels were considered a temporary measure.

During this inspection, the steel channel exhibited minor surface rust that encompassed approximately 75% of the surface area of the channels but was present along the full length of the channels.

During this inspection, the conditions of the steel channels and timber girders did not appear to have significantly changed when compared to inspection reports or photographs since 2015. Refer to photograph 4.

Steel channel mitigation - Girders 4 and 5 Span 2 - From Span 1 - Looking northeast

RecDate: 08/28/2019	EstCost:	Permanently mitigate the failure of
Action : Super-Rehab	StrTarget: 2 YEARS	Girders 4 and 5 in Span 2.
Work By: LOCAL AGENCY	DistTarget:	
Status : PROPOSED	EA:

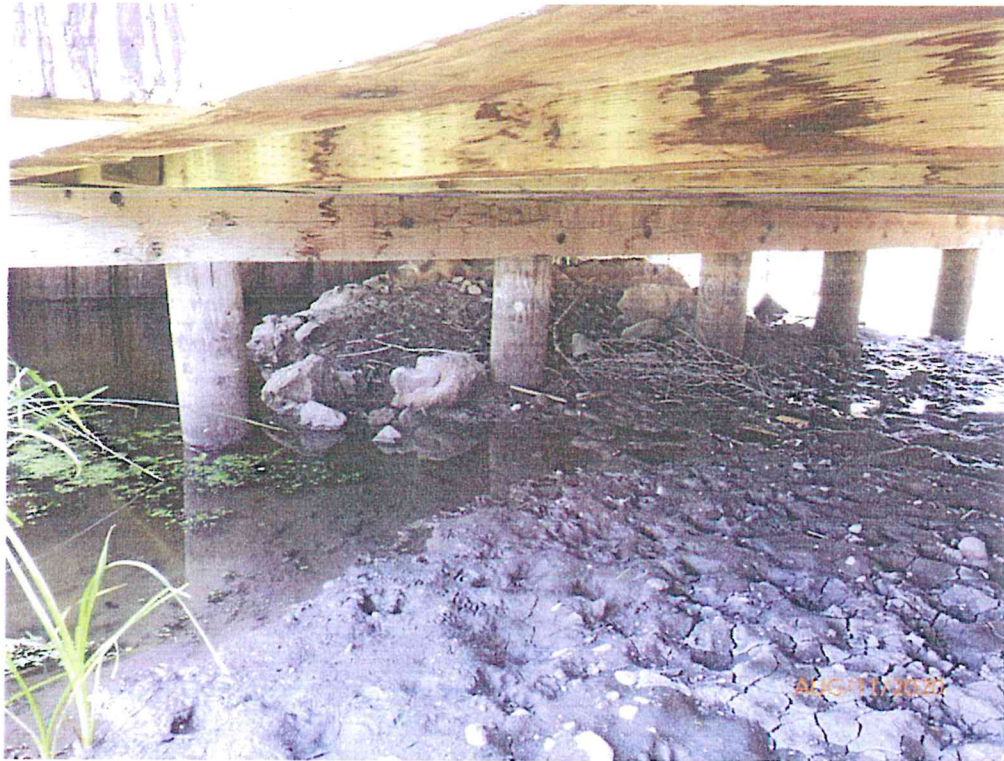
Photo No. 5

Vertical checks were present in Pile Extensions 1, 3 and 5 of Bent 2. The check was up to 0.25 inch in width x 3.5 inches in depth.

Bent 2 - From Abutment 1 left side - Looking southeast

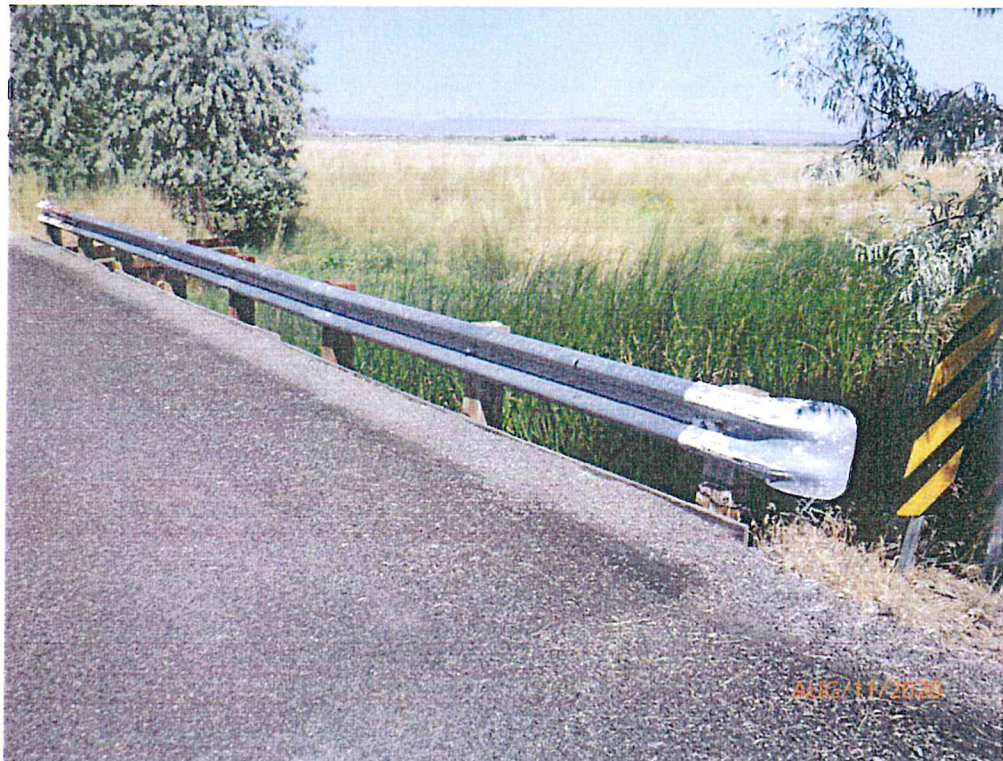
Photo No. 6

Prior to the 2014 inspection, portions of the bridge metal beam bridge rails were replaced: the majority of the beam on the left side of the bridge, a section of the beam at the right side of Span 1, and approximately 1/3 of the timber posts. The replaced portions of the beam encompassed approximately 50% of the total bridge lengths and were galvanized. The replaced posts were pressure treated.

Paint loss and minor surface were present on the non-replaced portions of the metal beam on both sides of the bridge. The paint failure consisted of exposure of the primer layer and exposure of metal.

The failed paint encompassed approximately 80% of the surface area, including exposed metal on approximately 20% of the surface area, and the entire length of the non-replaced portions of the metal beam.

Left rail - From Abutment 3 - Looking northwest

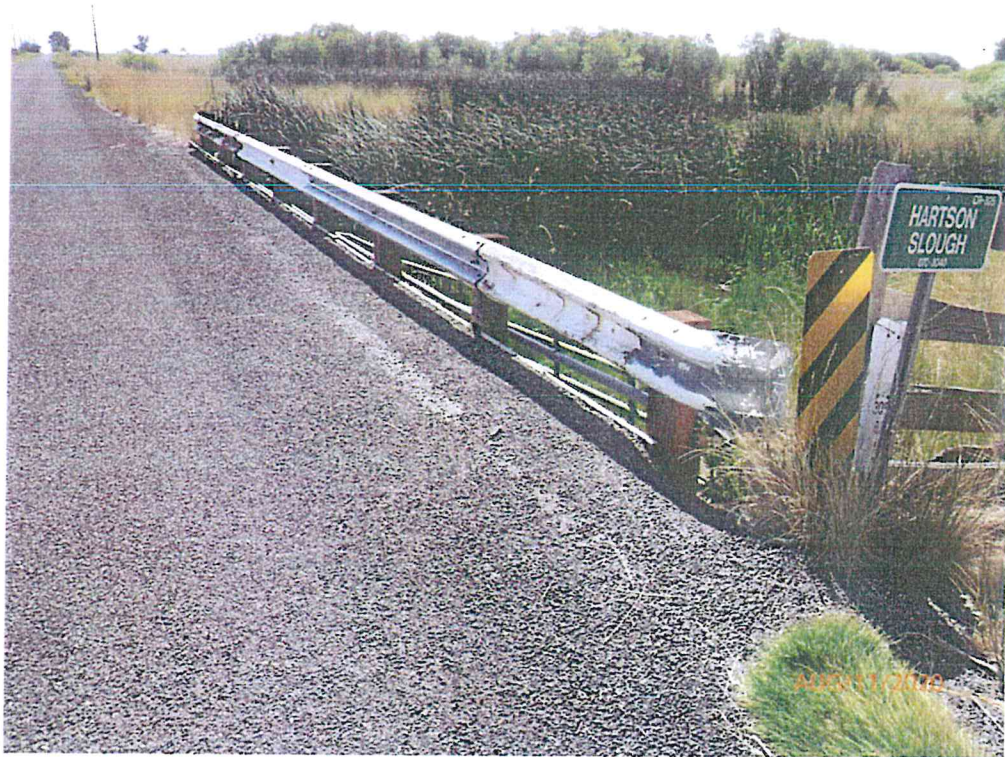
Photo No. 7

Right rail - From Abutment 1 - Looking southeast
