DUE DILIGENCE REPORT

LASSEN COUNTY COURTHOUSE SQUARE

MARCH 15, 2019

COUNTY OF LASSEN

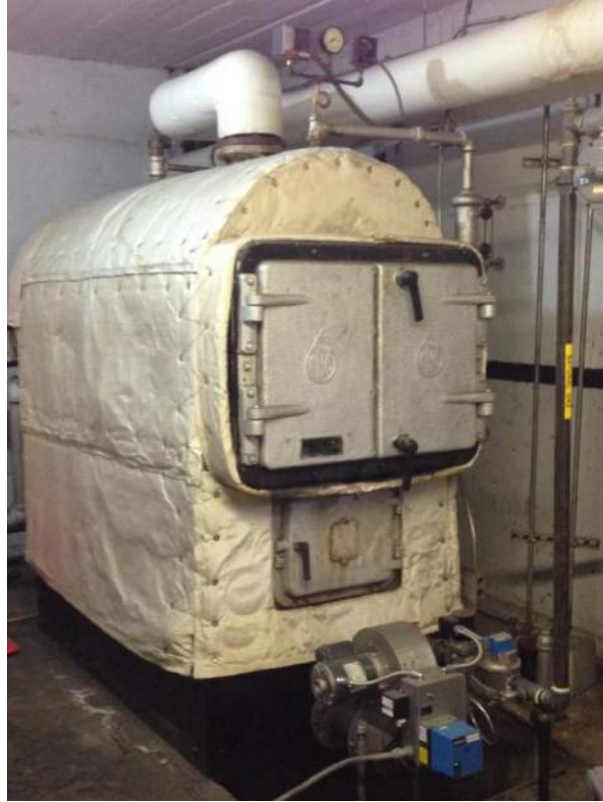
C.1 – COURTHOUSE HOT WATER BOILER WITH NEW BURNER

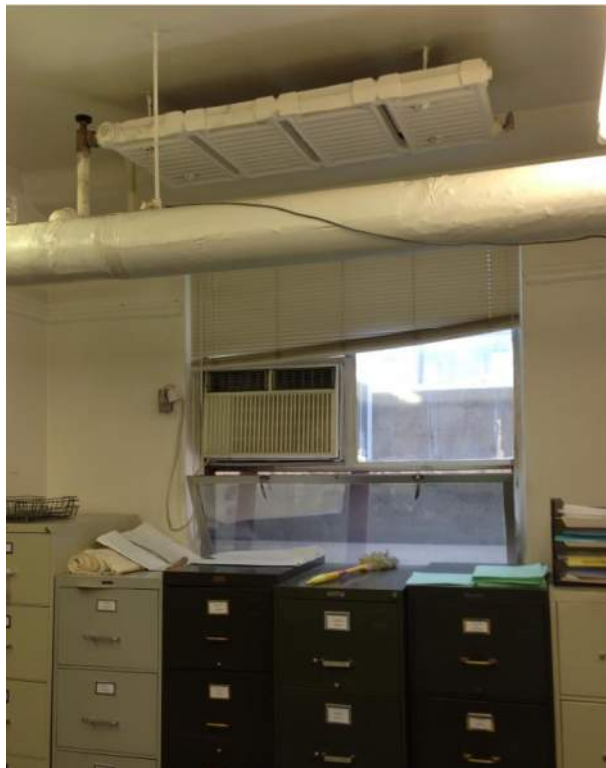
C.2 – COURTHOUSE PACKAGED AC UNIT & RADIATOR SERVING BASEMENT

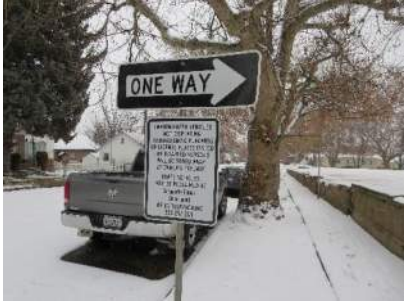
<p>1.</p>	<p>Issue: The existing parking sign at Driveway 1 (DW-1) is missing the word “special” as proscribed in the CBC. This is not a violation of the ADA but, the sign may be required to be replaced as part of path of travel upgrades required under the CBC for future alterations. See CBC Section 11B-202.4.</p> <p>Code Section(s): CBC 11B-202.4 and 11B-502.8.2</p>

<p>Remedy: Replace the existing sign with one that complies with the required wording in 11B-502.8.2.</p>	<p>Action Plan:</p>	<p>Completed:</p>
<p>2.</p>	<p>Issue: The striping of the parking space and access aisles is faded, not in the CBC proscribed blue and white colors. Accessible features are required to be maintained in a useable condition.</p> <p>The overall condition of the parking spaces could not be verified due to the continuing accumulation of snow during the site visit. Some of the asphalt appeared to be cracked and deteriorating. Accessible stalls should be free of cracks or holes exceeding ½” across or ¼” deep.</p> <p>Code Section(s): CBC 11B-502.6.4 and 11B-502.3.3</p>

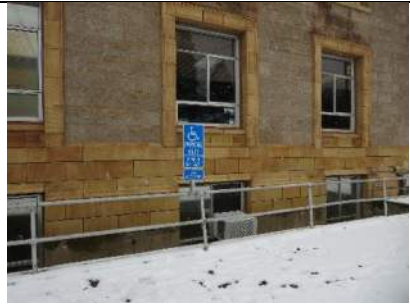
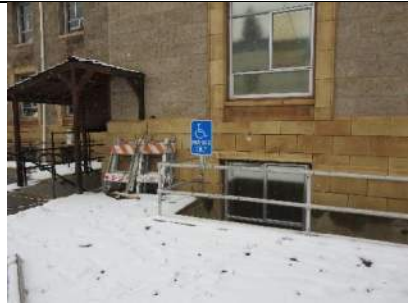
3.	Issue: Signs at accessible parking spaces are too low. They may not be visible when a vehicle is parked in the space.

Code Section(s): 11B-502.6		
	Remedy: Replace the sign posts and raise the signs to at least 60" AFF.	Action Plan:	Completed:
4.	Issue: The pedestrian route from accessible parking spaces AP1 through AP3 lacks the required warning between the pedestrian walking surface and the hazardous vehicular way. This warning can be truncated domes, curbs or rails, depending on location.

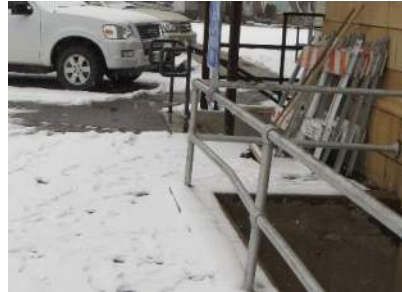
5.	<p>Issue: The light well near the accessible parking spaces had only a very low curb, with a large gap between the curb and the lowest rail. Abrupt changes in level exceeding 4" are required to have either a 6" high curb or a guard with a guide rail centered 2 to 4" above the walking surface.</p>

<p>Code Section(s): 11B-303.5</p>		
	<p>Remedy: It is recommended that an additional rail or safety bar be added to the guard.</p>	<p>Action Plan:</p>	<p>Completed:</p>

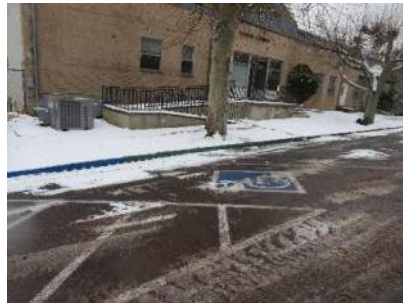
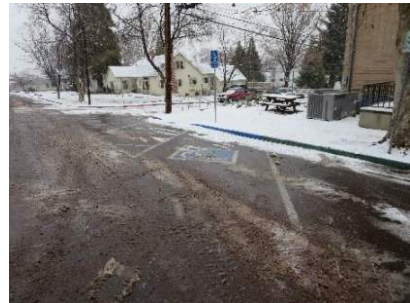
6.	<p>Issue: Accessible parking space AP-4, located on S. Roop St., in front of Building B, is not compliant. The space is required to be van accessible, since it is the only designated space in this location, but the access aisle is on the wrong side for a van space, and it is missing the van accessible sign. The parking space and access aisle both have excessive slopes, exceeding 2.0% in any direction. It is unclear if this space is part of the subject property or part of the PRow but, it appears to be the only accessible designated parking space that serves the public entrance to Building B, BE-2.</p>

<p>Code Section(s): 11B-208.3.1; 11B-502.3.4; 11B-502.6; 11B-502.8; 11B-502.4</p>		
	<p>Remedy: Either regrade the street and area for the accessible space or provide an accessible space around the corner, near BE-3, and provide an accessible route to the public entry door (BE-2).</p>	<p>Action Plan:</p>	<p>Completed:</p>

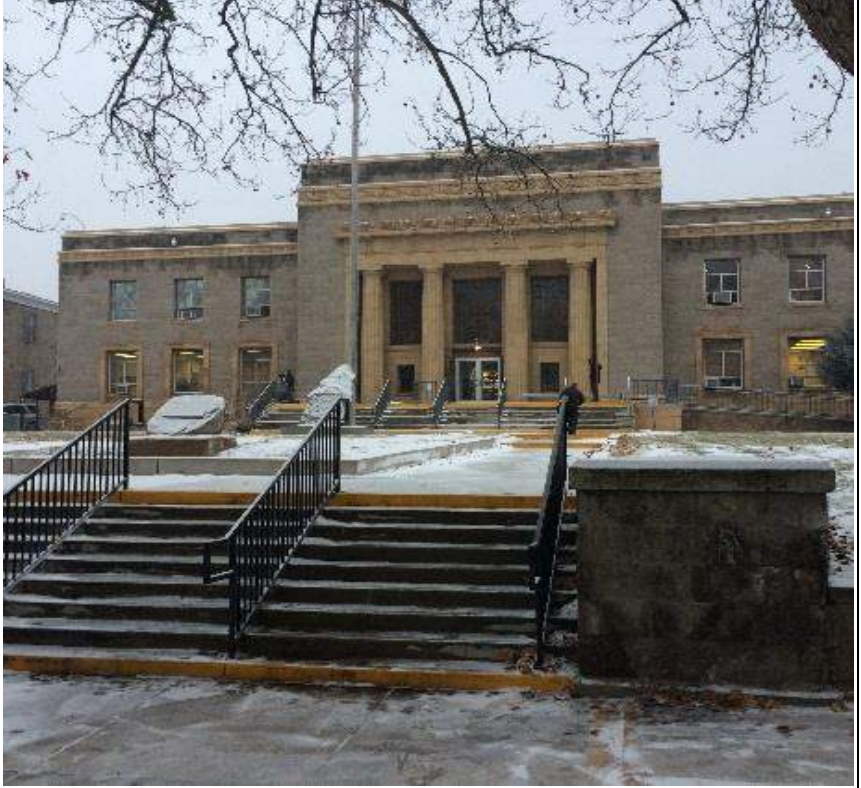
7.	Issue: Exterior Stair 1 (EST-1) lacks a visible ramp nearby and directional signage indicating the location of the nearest accessible route. The stairs also lack the required visual striping on every tread.

Code Section(s): 11B-206.2.1; 11B-206.2.2; 11B-216.6; 11B-402.2; 11B-403; 11B-504.4.1; 11B-216.6		
	Remedy: Either provide an accessible route with a ramp near this stair or provide directional signs indicating the location of the nearest accessible route. Add additional visual stripes to the treads.	Action Plan:	Completed:

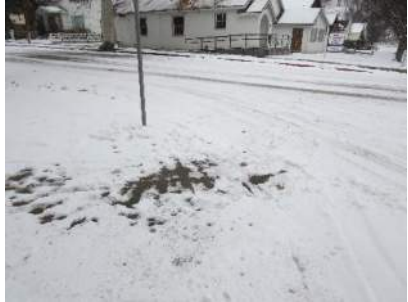
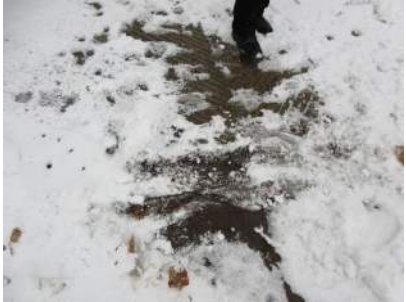
8.	<p>Issue: The curb ramp (CR-1) at the corner of S. Lassen and Mill streets is an older style diagonal curb ramp located within the public right of way. It is missing truncated domes, although it has warning grooves along the sloped surface. The lip at the street was clogged with ice at the time of survey but appeared to be over ½" vertical. The counter slope at the street was excessive at 8.3% (5.0% is the max. allowed). This curb ramp is included in this report because it is on the route to the nearest public transportation (bus) stop, and access from public transportation routes must be provided. It was unknown at the time of the survey if the curb ramp is part of the subject property or under the Owner's control.</p> <p>Code Section(s): 11B-206.2.1; 11B-247.1.2.2; 11B-406.5.4; 11B-406.5.8</p>

<p>Remedy: Responsibility for the curb ramp is unknown. This curb ramp is on the shortest route to the nearest bus stop and may need to be replaced as part of the accessible route from/to public transportation. Coordinate with the County's ADA Transition Plan.</p>	<p>Action Plan:</p>	<p>Completed:</p>

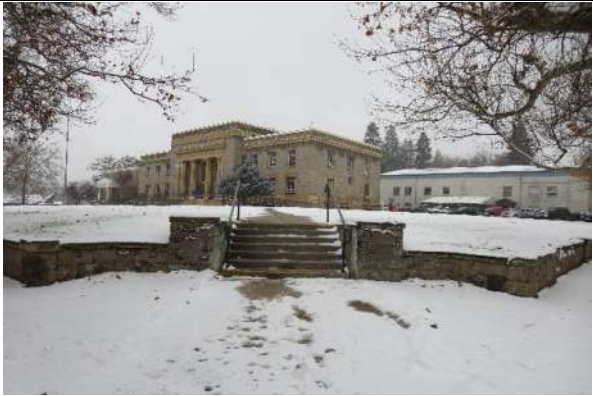
9.	<p>Issue: Exterior Stair (EST-3) lacks a visible ramp nearby and directional signage indicating the location of the nearest accessible route. The stairs also lack the required visual striping on every tread and handrail extensions.</p> <p>Code Section(s): 11B-206.2.1; 11B-206.2.2; 11B-216.6; 11B-402.2; 11B-403; 11B-504.4.1; 11B-216.6</p> <p>Remedy: Either provide an accessible route with a ramp near this stair or provide directional signs indicating the location of the nearest accessible route. Add additional visual stripes to the treads. Replace the handrails with compliant rails.</p>

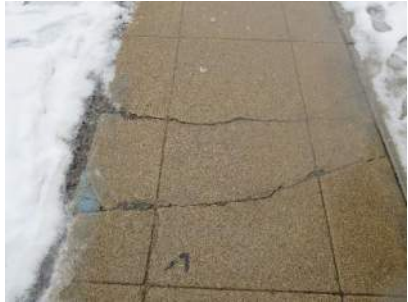
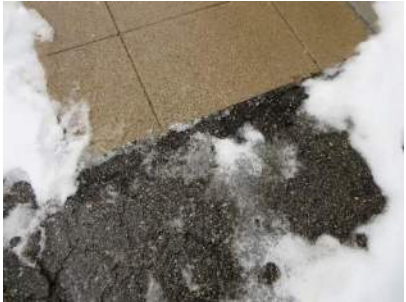
10.	<p>Issue: Accessible Route 3 (AR-3), the route between the accessible parking spaces and Ramp 1 (R-1) has some cracks and holes that exceed ¼" across. The transition between the asphalt and concrete surfaces is rough and exceeds ¼" vertical.</p> <p>AR-3 was also noted to be less than the CBC required 44" width, but did meet the ADA requirement of 36" min. wide. The width of this route may need to be changed as upgrades for future work under the CBC, but is compliant for the purposes of providing access under the ADA.</p>

<p>Code Section(s): 11B-206.2.1; 11B-206.2.2; 11B-403.2; 11B-403.4; 11B-403.5; 11B-302; 11B-303</p>		
	<p>Remedy: Grind down humped up asphalt. Fill holes and cracks as needed.</p>	Action Plan:	Completed:

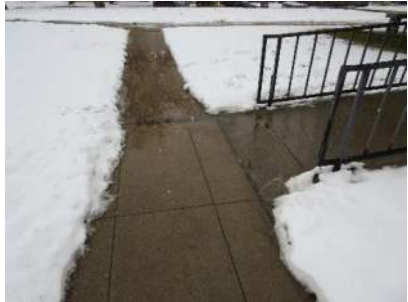
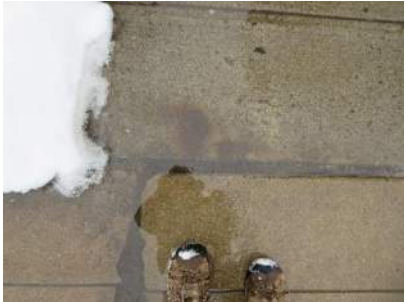
11.	<p>Issue: The landing at the bottom of Ramp 1 (R-1) has standing water and does not drain well.</p>

<p>Code Section(s): 11B-405.10</p>		
	<p>Remedy: Either re-grade the surrounding landscape area to provide better drainage or install a drain with compliant grate.</p>	Action Plan:	Completed:

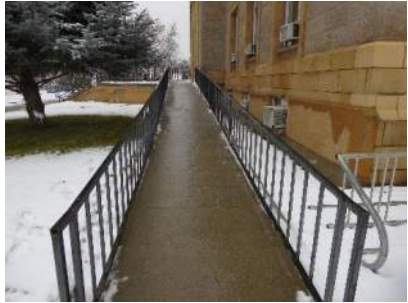
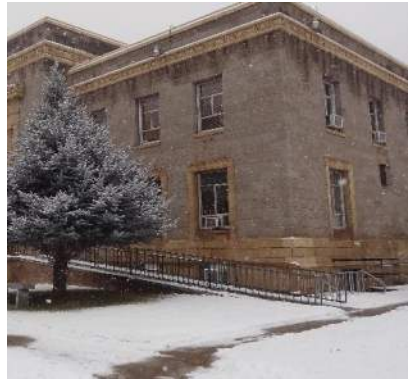
12.	<p>Issue: Ramp 1 (R-1) has an excessive running slope, measuring up to 10%. It is 44 feet long with no intermediate landing, and has non-compliant rails. The bottom landing is not long enough (72" long, min.)</p>

<p>Code Section(s): 11B-405, especially 11B-405..2, 11B-405.6, 11B-405.7, and 11B-405.8; 11B-505</p>		
	<p>Remedy: Replace the ramp, rails, and landings with a compliant ramp that does not exceed 8.33% with a 30" max. rise and has intermediate landings as required for the length, and compliant handrails.</p>	<p>Action Plan:</p>	<p>Completed:</p>

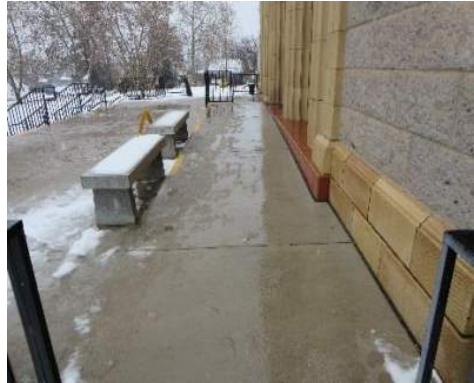
13.	<p>Issue: Accessible Route 4 (AR-4) includes the top landing of R-1 and continues to the entrance. The cross slope in this area is excessive, measuring from 3.0 to 3.4% (2.0% is the max. allowed).</p>

<p>Code Section(s): 11B-405.3, 11B-403.3</p>		
	<p>Remedy: Replace all or portions of the walking surface as needed to provide a route with a cross slope that does not exceed 2.0%.</p>	<p>Action Plan:</p>	<p>Completed:</p>

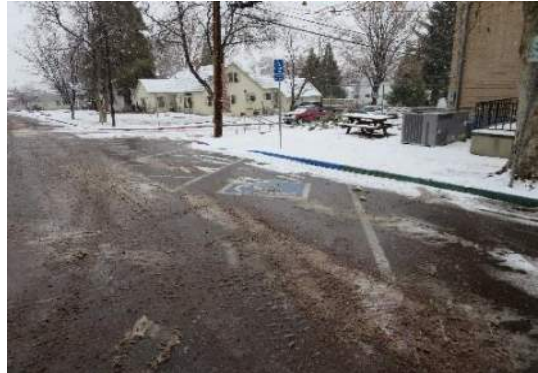
14.	<p>Issue: There is no accessible route (AR-5) between the designated accessible parking space AP-4 and the entrances to either Building A or Building B.</p>

<p>Code Section(s): 11B-206.2.1</p>		
	<p>Remedy: Install a curb ramp at the corner of S. Roop and Mill Streets. See also AP-4, item number 6 in this report, for additional information.</p>	<p>Action Plan:</p>	<p>Completed:</p>
15.	<p>Issue: Ramp 2 (R-2) is not compliant. It has excessive running slopes measuring from 8.2 to 11.5%; the handrails lack the required extensions, and the bottom landing is less than the required 72" min. length.</p>

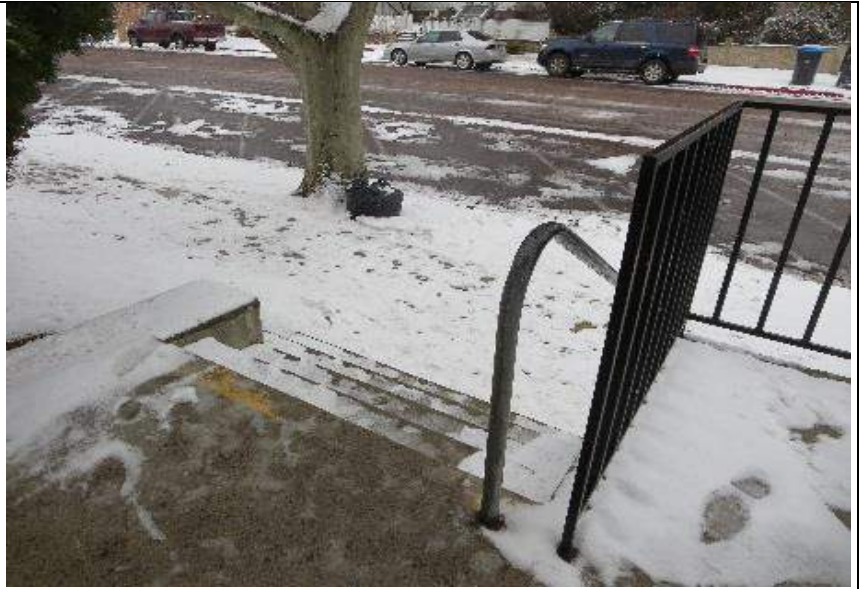
16.	<p>Issue: Exterior Stair 6 (EST-6) is missing the guard and handrail on one side. The steps lack the required visual stripes on the intermediate steps.</p>

<p>Code Section(s): 11B-210; 11B-505.2, 11B-504.4.1</p>		
	<p>Remedy: Install a compliant guard and handrail, install a visual stripe on each stair tread and the top approach.</p>	<p>Action Plan:</p>	<p>Completed:</p>

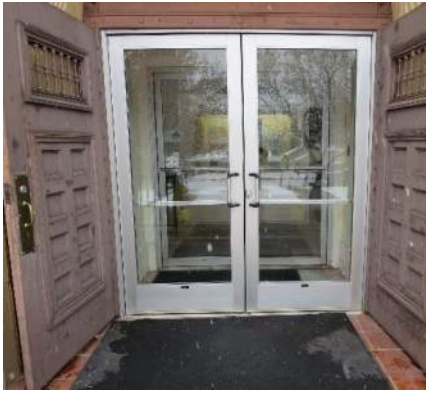
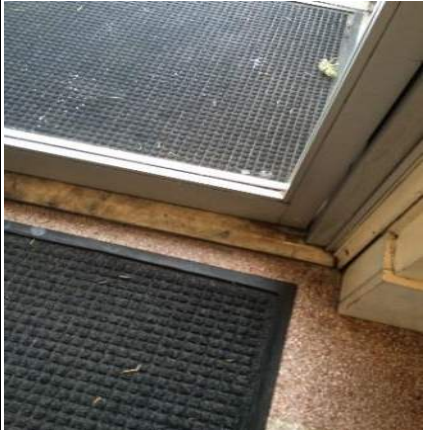
17.	<p>Issue: Building Entrance 1 (BE-1) is the main entrance to the building and has multiple access issues. The doors are a double set of doors that are less than 48" clear apart. There is a ½" vertical marble threshold. The interior pair of doors has a 4" high bottom stile. There is a flip down style hold open at the bottom of the push side of the door. The walk off mats on the interior side of the door are not permanently affixed to the floor. This is the door nearest the exterior ramp, and is presumed to be the accessible door. There is no directional signage pointing to another door as the accessible door and no ISA on this door indicating that it is the accessible entry.</p>

<p>Code Section(s): 11B-206.4; 11B-404.2.6, 11B-303, 11B-404.2.10, 11B-302.2, 11B-206.2.4</p>		
	<p>Remedy: Remove one set of doors, remodel the entry to provide the required clear distance between doors, or install automatic door openers that open both sets of doors together as an alternate method of compliance. Remove the walk off mats or replace the mats with permanently affixed mats. Add a kick plate with top closure to the doors to provide a 10" bottom stile on the push side of the door. Remove the flip down hold opens. Replace the threshold or provide additional transition pieces to ramp on each side at a max. of 1:2. If this is to be the accessible entry, add an ISA to the active door leaf.</p>	<p>Action Plan:</p>	<p>Completed:</p>

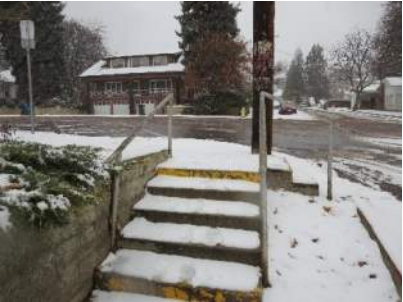
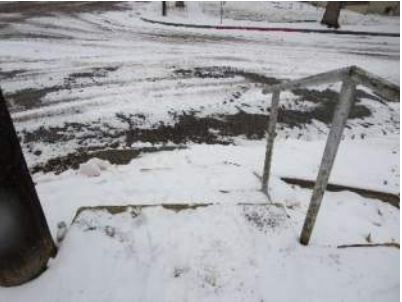
18.	<p>Issue: It is unclear if Exterior Stair 4 (EST-4) and Exterior Stair 5 (EST-5) at the corner of S. Roop and Mill streets are a part of the subject property or are in the Public Right of Way (PRoW). There are no adjacent ramps and no directional signs indicating that location of the accessible route. The stairs lack the required visual stripes and compliant handrails.</p> <p>Code Section(s): 11B-206.2; 11B-505.2, 11B-504.4.1</p>

<p>Remedy: Remove the steps and replace with ramps or sloped walking surfaces. If the steps are in the PRoW, then provide an alternate route within the subject site. See also the comments on the Building Entrances for Building B.</p>	<p>Action Plan:</p>	<p>Completed:</p>

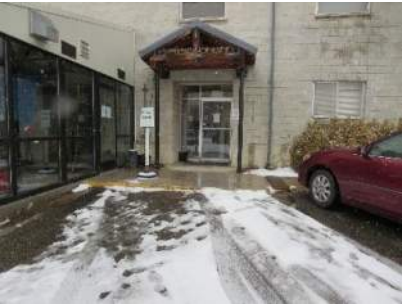
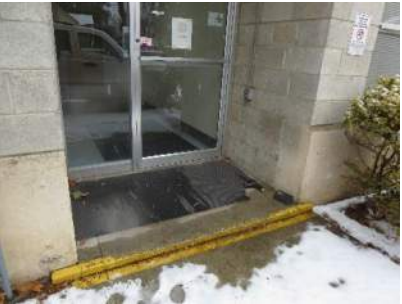
19.	<p>Issue: Building B Lower Level lacks an accessible entrance.</p> <ul style="list-style-type: none"> • BE-3 has a step up and is not on an accessible route from parking and the PRoW. • BE-4 is not on an accessible route from parking and the PRoW. • BE-5 and BE-6 are not on accessible routes from parking and the PRoW. <p>Note: The lower level of Building B is not currently open to the public or used. This information is provided for future planning purposes.</p> <p>Code Section(s): 11B-206.2.3</p> <p>Remedy: Since this level is not currently used, this is not a violation. When the area is eventually reopened, at least one accessible entrance on an accessible route should be provided.</p>

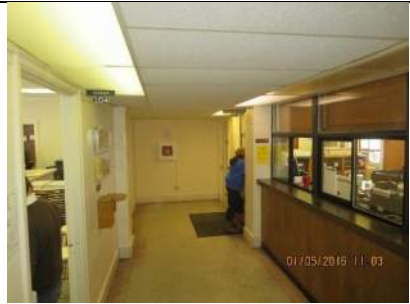
3.	<p>Issue: Building A - The elections counter in the basement level is too high to be accessible, and is a protruding hazard. The service window at the Recorder and Auditor, the Treasurer and Tax Collector, and County Clerk, all on the first floor, are also not accessible. They are too high and lack a knee space for a work surface.</p>

<p>Code Section(s): 11B-227; 11B-904.4</p>		
	<p>Remedy: Either relocate the functions to an accessible area or reconfigure the counters so that they provide an accessible surface and are not a hazard to visually impaired persons.</p>	<p>Action Plan:</p>	<p>Completed:</p>

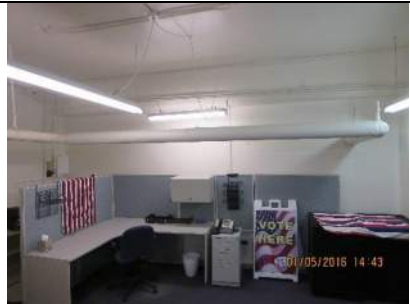
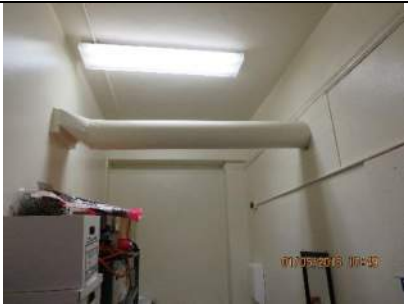
4.	<p>Issue: Building A - The basement level has numerous pipes and ducts crossing overhead. Some of these are less than the required 80" AFF, creating a hazard.</p>

<p>Code Section(s): 11B-307.2</p>		
	<p>Remedy: It is unclear if the public is allowed in the basement level. If they are, limit access to areas that do not have low hanging objects. The mechanical engineer on site the day of the inspection indicated that additional study would be needed to either raise the pipes or determine that such modifications are technically infeasible, as they are part of the building's original construction. Until such a determination is made, it is recommended that these areas be off limits to the public.</p>	<p>Action Plan:</p>	<p>Completed:</p>

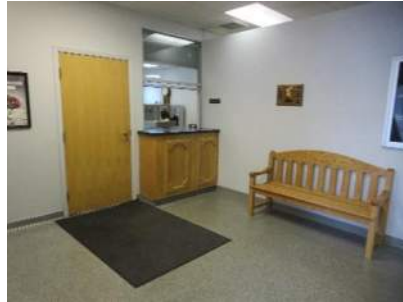
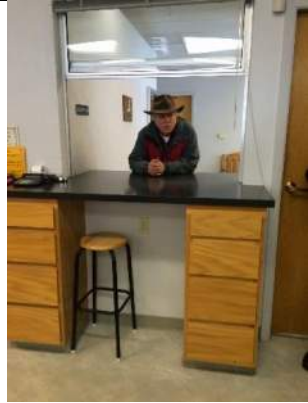
6.	<p>Issue: Building B Auditor's office public counter is 42" high without a knee space on the public side. Additionally, the counter extends into the required 18" pull side door clearance for the Auditor's office door. It is unclear if Auditor's office door is used by the public. If used by the public, it should be made accessible. If used by staff only, it is subject to Title I Employee Accommodations as needed.</p>

<p>Code Section(s): 11B-227; 11B-904.4; 11B-404.2.4</p>		
	<p>Remedy: Either lower the counter or provide an additional low work surface with required depth and knee space. If door needs to be accessible, cut back counter to provide maneuvering space.</p>	<p>Action Plan:</p>	<p>Completed:</p>
