DUE DILIGENCE REPORT

LASSEN COUNTY COURTHOUSE SQUARE

MARCH 15, 2019

COUNTY OF LASSEN

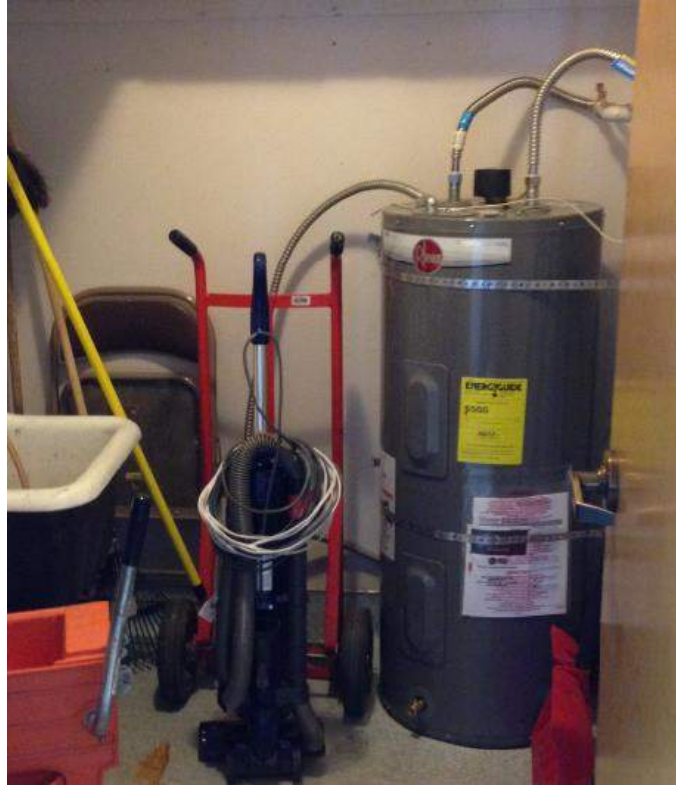
A.3 – ANNEX ELECTRIC WATER HEATER

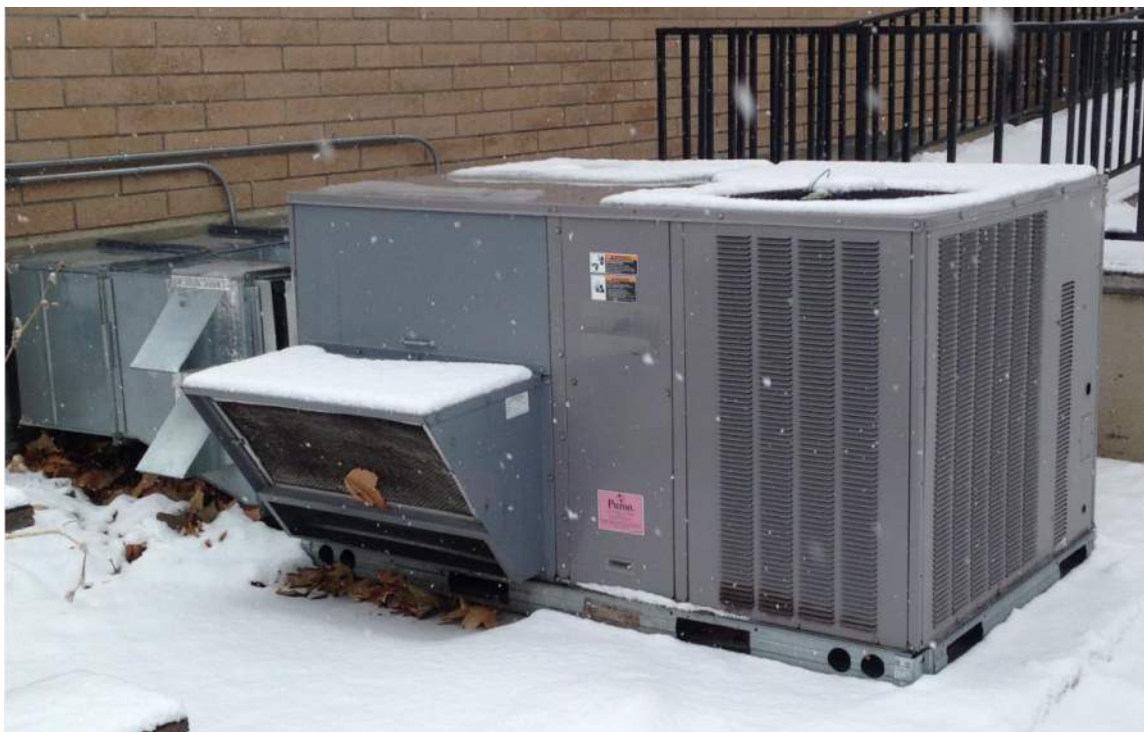
A.4 – ANNEX PACKAGED HVAC UNIT SERVING DATA CENTER

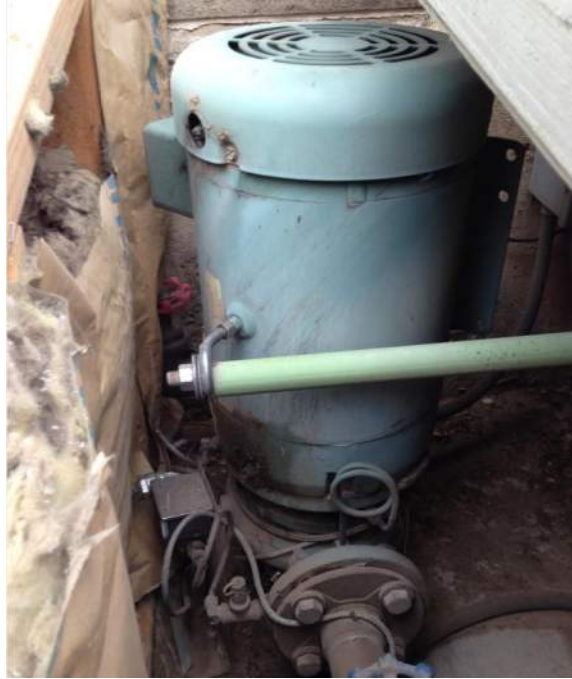
A.4 – ANNEX CONDENSER WATER PUMP

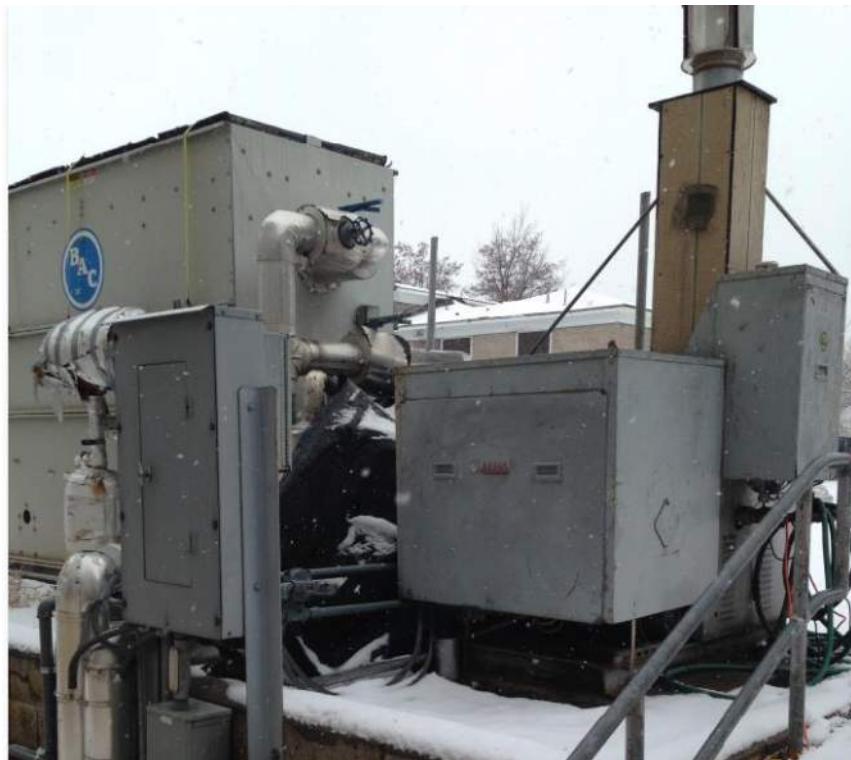
A.5 – ANNEX FLUID COOLER AND HOT WATER BOILER

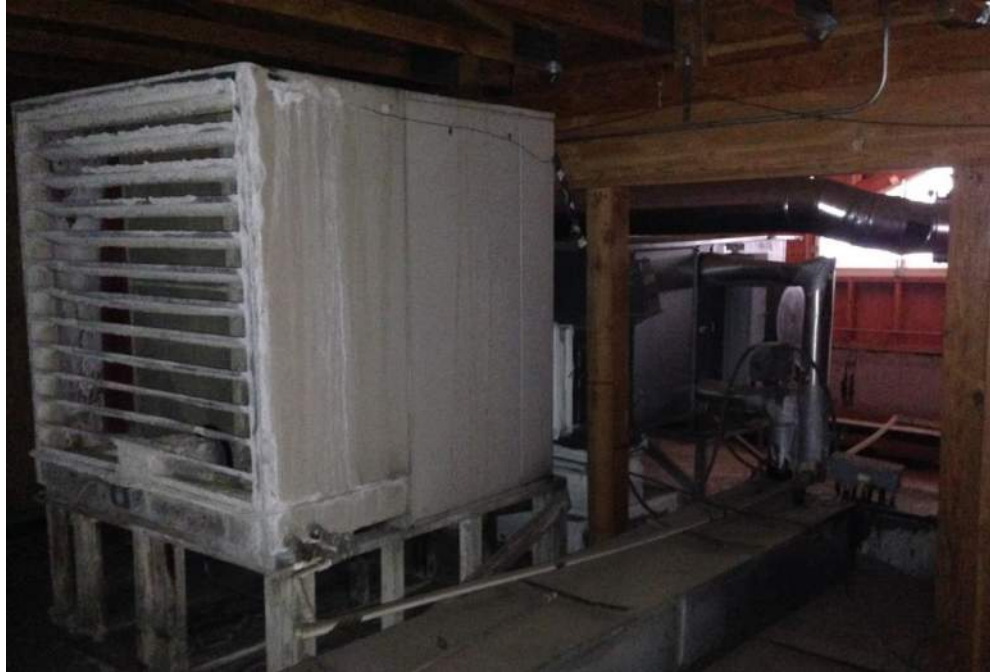
A.6 – ANNEX ABANDONED EQUIPMENT IN ATTIC

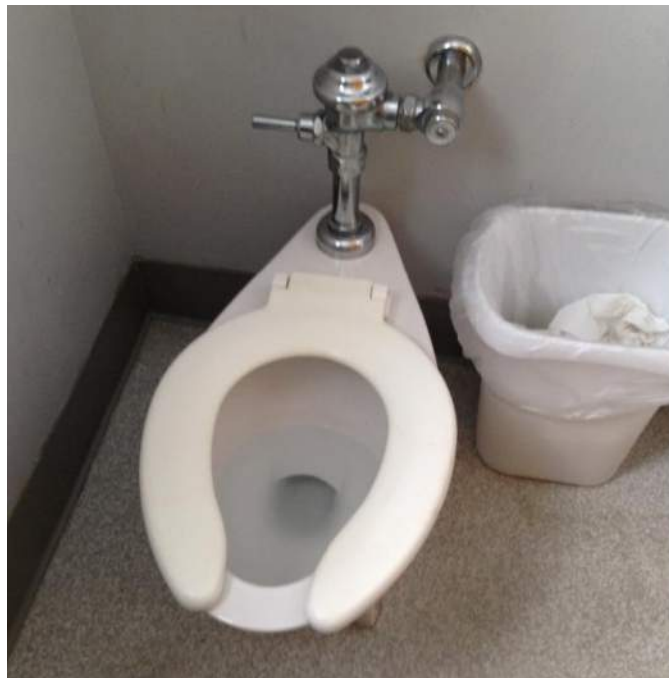
A.7 – ANNEX RESTROOM TOILET WITH FLUSH VALVE (TYPICAL)

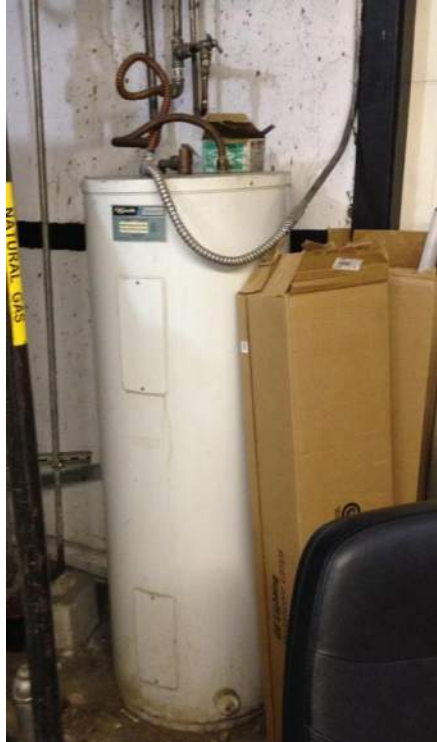
C.3 – COURTHOUSE BASEMENT ELECTRIC WATER HEATER

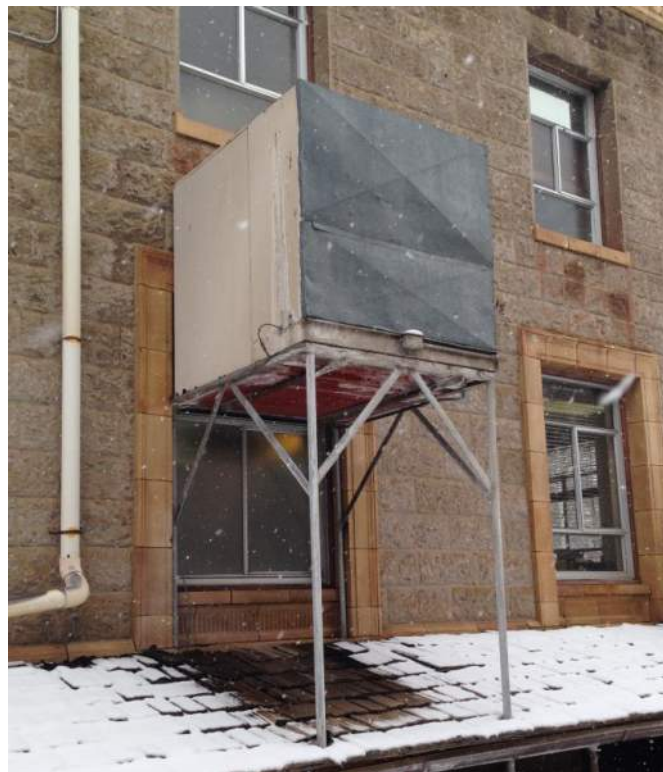
C.4 – COURTHOUSE EVPORATIVE COOLING UNIT SERVING 1ST FLOOR

Because there was no original cooling system, it is recommended to remove the window units and swamp cooler and provide a consistent split air conditioning or Variable Refrigerant Flow (VRF) system to serve the entire building. A forced air system would be difficult to incorporate into this building due to the larger sized ducts that would be required. A fluid-based VRF system, like the one already installed in the Judge's Chambers, allows for efficient cooling units to be placed throughout the building with less impact on existing finishes and structure. This is an important consideration for a building on the National Register of Historic Places – HVAC systems must be designed so as not to detract from the aesthetic and historic character defining features of the building.

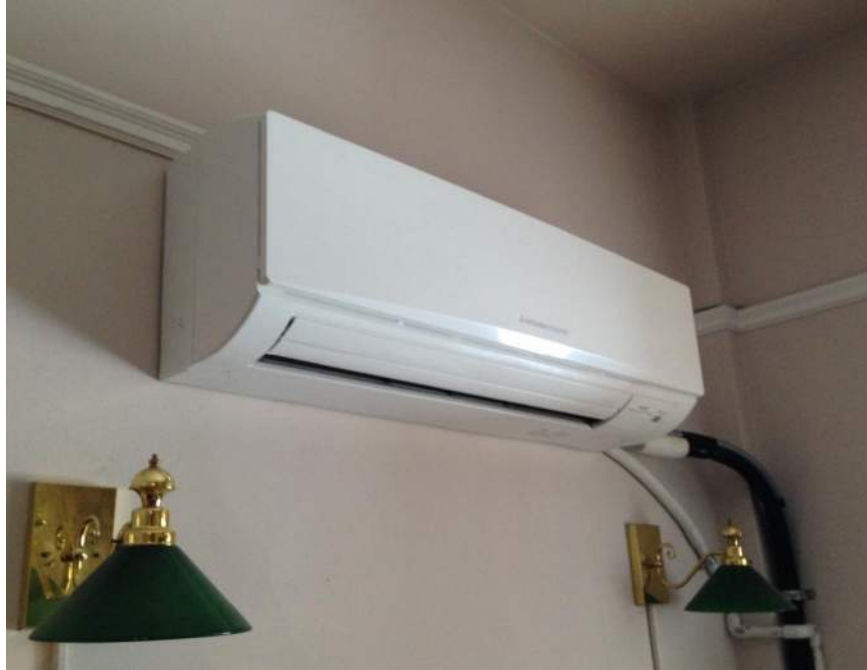
C.5 – SPLIT SYSTEM FAN COIL SERVING 3RD FLOOR

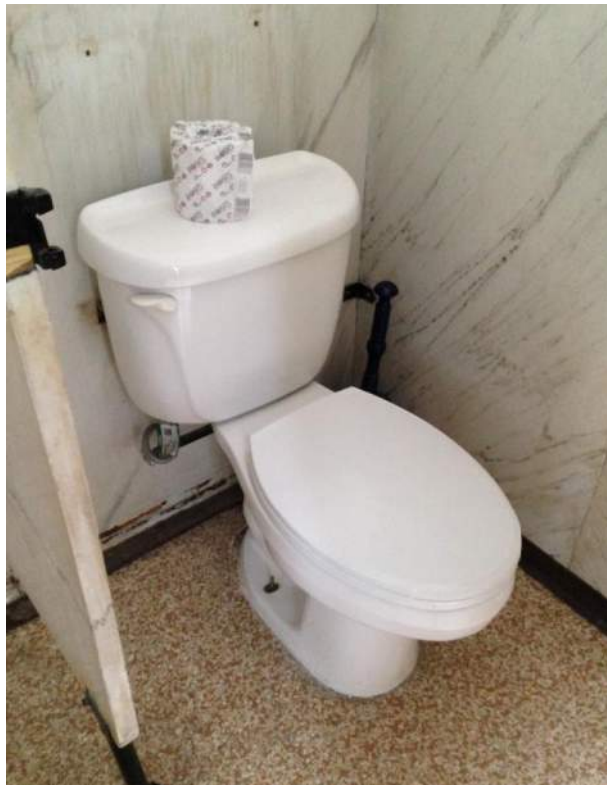
C.6 – COURTHOUSE FLUSH TANK TOILETS (TYPICAL)

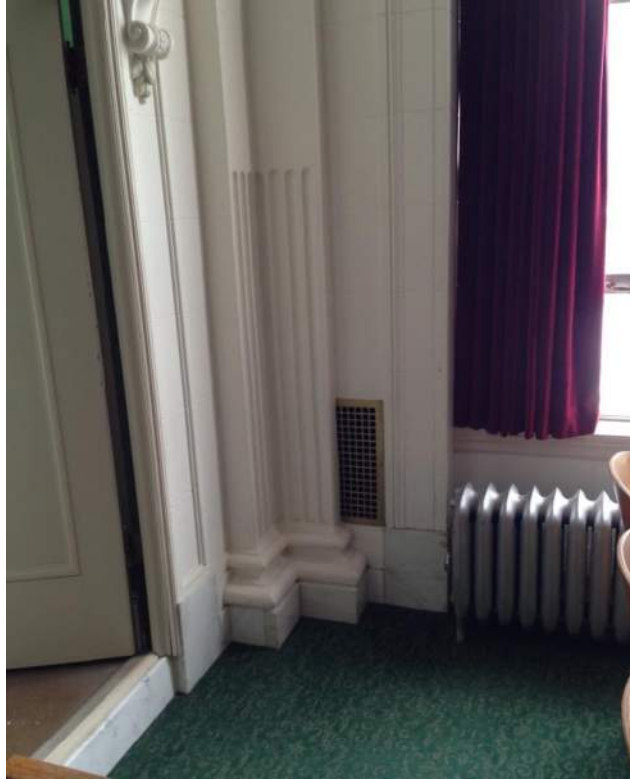
C.7 – COURTHOUSE COURTROOM RADIATOR AND WALL GRILL

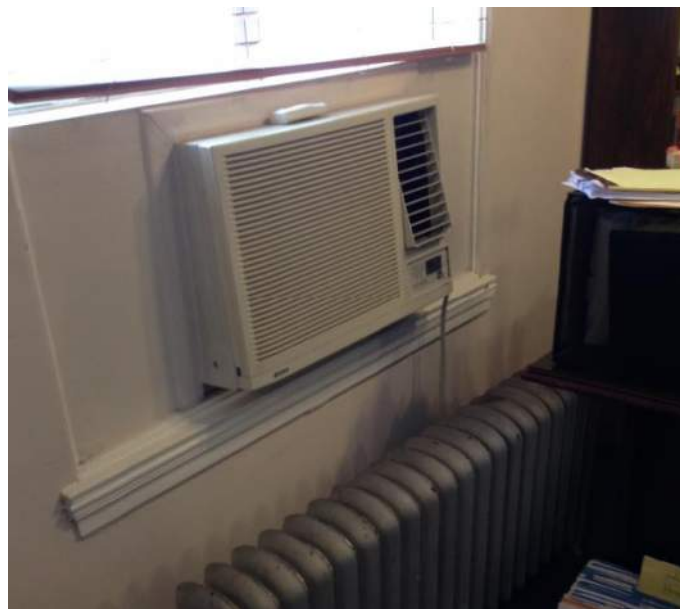
C.8 – COURTHOUSE 2ND FLOOR RADIATOR AND PACKAGED AC UNIT (TYPICAL)

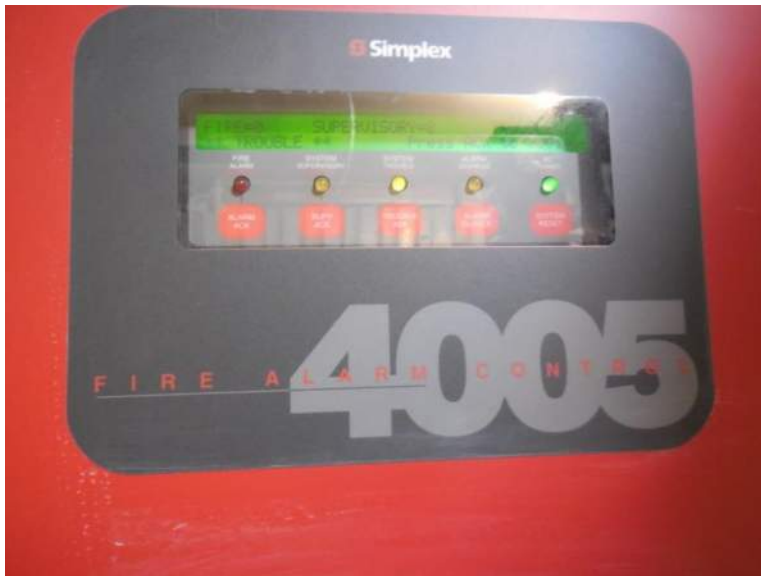
A.8-Annex fire alarm control panel

RECOMMENDATION: Install a new fire alarm system that will comply with NFPA 72 requirements in force at the time of the design and installation of the system.

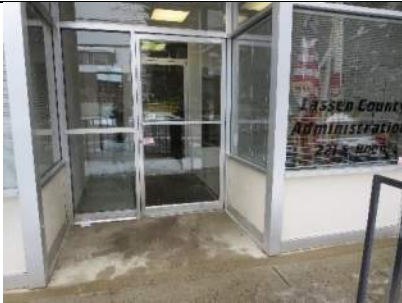
20.	<p>Issue: Building B Upper Level public entrance (BE-2) is not on an accessible route from parking and public transportation stops. It lacks the required ISA to be used at accessible doors when not all building doors are accessible.</p>

<p>Code Section(s): 11B-206.2.1; 11B-216.6</p>		
	<p>Remedy: Provide ISA on door after route has been fixed, if this is to be the accessible entrance.</p>	<p>Action Plan:</p>	<p>Completed:</p>

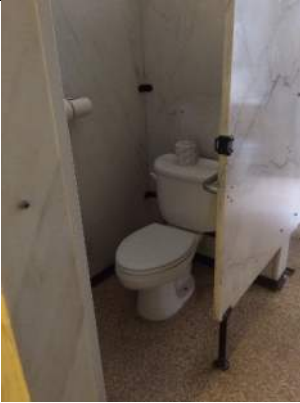
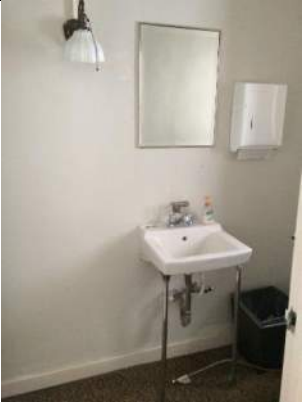
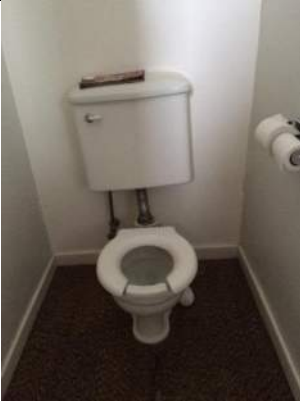
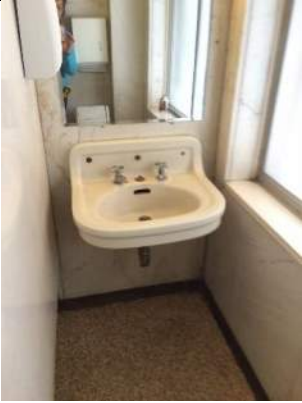
1.	Issue: Building A - The existing toilet rooms on all four levels of this building are not accessible. No accessible toilet room for the public is provided.

Code Section(s): 11B-213; 11B-603		
	Remedy: Either remodel existing toilet rooms on levels open to the public so they are accessible, or provide additional accessible toilet rooms and directional signs at inaccessible ones indicating the location(s) of the nearest accessible toilet room(s).	Action Plan:	Completed:

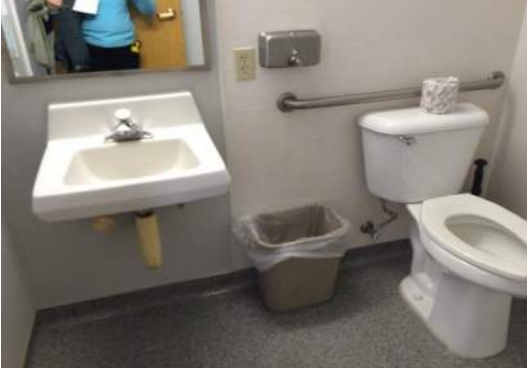
2.	<p>Issue: Building B, Upper Level Women's Toilet Room (public) is compliant in size for 1991 ADA and 2010 CBC regulations. However, future building alterations may trigger upgrades to the 2010 ADA/current CBC, which requires more than the provided 28" clear space between the water closet and the lavatory.</p>

<p>Code Section(s): 11B-202.4 exception 2</p>		
	<p>Remedy: No action needed at this time. Item is for future planning purposes.</p>	<p>Action Plan:</p>	<p>Completed:</p>

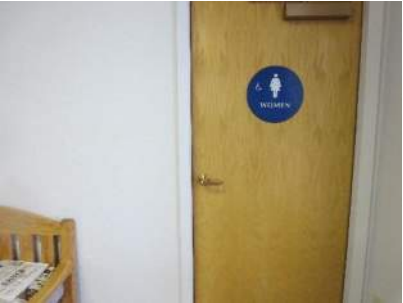
3.	<p>Issue: Building B, both Men's and Women's upper level toilet rooms lack the required tactile room identification signage with accompanying braille characters. Geometric door signs contain pictograms which are required by code to have accompanying braille characters, and braille is not allowed on door signs.</p>

<p>Code Section(s): 11B-216.8; 11B-703.7.2.6</p>		
	<p>Remedy: Provide compliant visual and tactile signs at the latch side of each door. Provide compliant geometric signs on the door panels.</p>	<p>Action Plan:</p>	<p>Completed:</p>

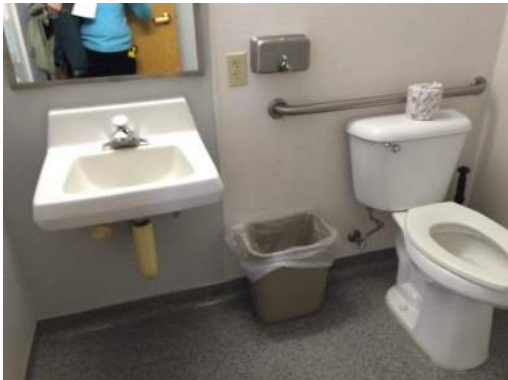
4.	Issue: Building B, Upper Level Women's Toilet Room (public) has only 17 ½" clear from side wall to the centerline of the lavatory. This is compliant under the ADA, which requires only 15" but, not under the CBC, which requires 18" min. clear. Additionally, the lavatory knee space at the front apron is only 28 ¾" high, and 29" min. is required. The supply and drain pipes are not all insulated or protected against contact.

Code Section(s): 11B-213; 11B-603; 11B-606.2; 11B-606.5; 11B-606.6; 11B-306	Action Plan:	Completed:
	Remedy: Install a smaller lavatory that maintains the 28" clear between the toilet and lavatory but increases the distance to the side wall. Raise the lavatory as needed to provide required knee space clear height. Insulate all supply and drain pipes.

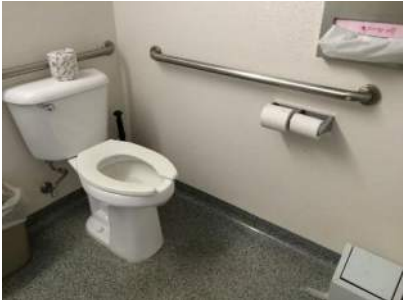
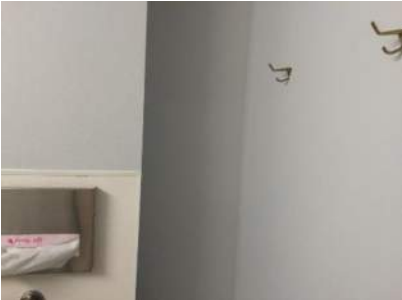
5.	Issue: Building B, Upper Level Women's Toilet Room (public) has some accessories that are mounted too high: the mirror is at 41" from the finished floor to the edge of the reflective surface (40" max. allowed); the soap dispenser is 41" high to the operable parts (40" max allowed); and the coat hooks are above the max. allowable 48" AFF. The freestanding trash can is in the required clear floor area for the water closet. The seat cover dispenser is located too low over the grab bar.

Code Section(s): 11B-603.5; 11B-609.3	Action Plan:	Completed:
	Remedy: Lower the mirror and soap dispensers; provide additional coat hooks at a compliant height. It is recommended that a wall mounted trash can be installed outside all required clear floor areas and maneuvering spaces for fixtures, room, or door. If a fixed trash can is not provided, instruct cleaning and maintenance staff on the allowable locations for a free standing trash can and have them maintain that configuration. Relocate the seat cover dispenser.

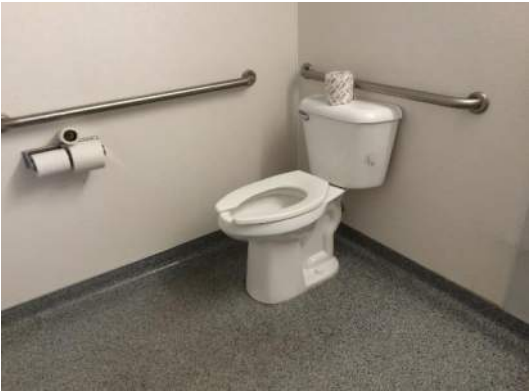
6.	<p>Issue: Building B, Upper Level Men's Toilet Room (public), has the water closet located 18 ½" from the side wall to the centerline. At the time of construction, 18" absolute was required under both the ADA and the CBC, and a ½" tolerance was often considered acceptable. However the 2010 ADA changed the requirement to a range of 16 to 18", and the 2013 CBC allows 17 to 18". The dimension is outside the current allowed ranges for both, and may need to be modified in the future.</p> <p>Code Section(s): 11B-202.4 exc. 2; 11B-604.2</p>

<p>Remedy: If the floor is of wood construction, it is usually possible to move the toilet flange over into acceptable range. If the flange can't be moved, then the wall can be furred out so it is closer to the toilet.</p>	Action Plan:	Completed:

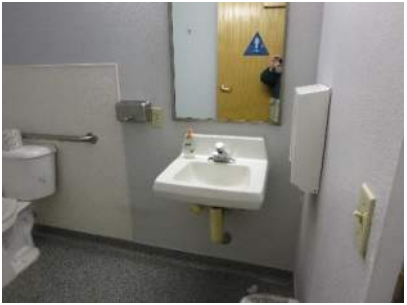
7.	<p>Issue: Building B, Upper Level Men's Toilet Room (public) has some accessories that are mounted too high: the mirror is at 40 ¾" from the finished floor to the edge of the reflective surface (40" max. allowed); the soap dispenser is 40 ½" high to the operable parts (40" max allowed); and the coat hooks are above the maximum allowable 48" AFF.</p> <p>Code Section(s): 11B-603.3; 11B-603.5</p>

<p>Remedy: Lower the mirror and soap dispenser; provide additional coat hooks at a compliant height.</p>	Action Plan:	Completed:

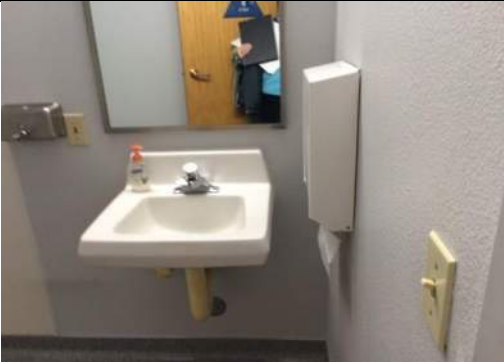
8.	<p>Issue: Building B, Upper Level Men's Toilet Room (public) lavatory is slightly too low at the front apron. The bottom of the apron measures 28 7/8", and 29" minimum is required. The lavatory also lacks the required supply and drain insulation at all pipes.</p>

<p>Code Section(s): 11B-606.2; 11B-606.5</p>		
	<p>Remedy: Raise the lavatory to provide the minimum required knee space; insulate all supply and drain pipes.</p>	Action Plan:	Completed:
9.	<p>Issue: Building B, Upper Level Men's Toilet Room (public), has a toilet paper dispenser that is not 7 to 9" from the front edge of the toilet to the center of the dispenser.</p>

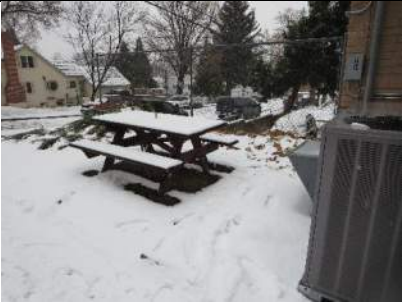
3.	<p>Issue: The picnic table on the exterior of Building B does not have an accessible route to it and does not provide a seat that accommodates a wheelchair user. It is unclear if this table is for public use or is intended for employee use but, as it is clearly visible and can be accessed from the PRoW, it is assumed that it is available for the public.</p>

<p>Code Section(s): 11B-246.5; 11B-206.2.2</p>		
	<p>Remedy: Provide an accessible table with accessible route leading to it, or remove the table.</p>	<p>Action Plan:</p>	<p>Completed:</p>

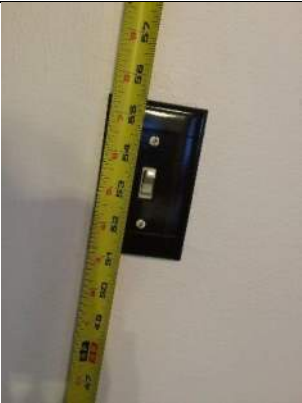
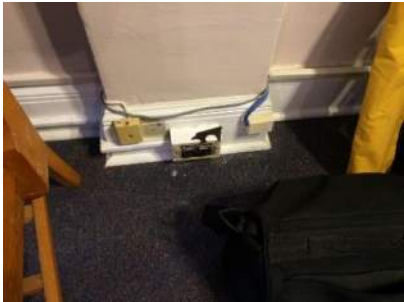
5.	<p>Issue: Building A, the Courthouse, has multiple locations with switches, electrical receptacle outlets, and other building controls that are not within the allowable reach ranges of 15" minimum AFF and 48" maximum AFF.</p>

<p>Code Section(s): 11B-205; 11B-308</p>		
	<p>Remedy: Operable parts should be brought into required reach ranges, with priority given to rooms and spaces that are open to the public, and elements that the public may utilize.</p>	<p>Action Plan:</p>	<p>Completed:</p>

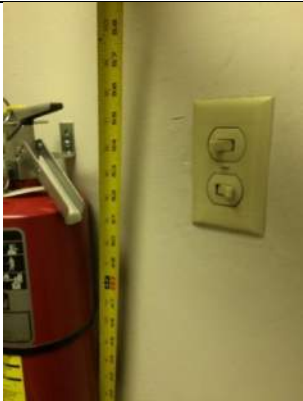
7.	Issue: Building A, the fire extinguisher located at the 2 nd floor corridor, outside the right Courtroom door, is mounted too high.

Code Section(s): 11B-205; 11B-308		
	Remedy: Lower the extinguisher so that all operable parts are within 48" AFF. Care should be taken to ensure that the FE is not a protruding hazard if relocated.	Action Plan:	Completed:
8.	Issue: The Courtroom / Board of Supervisor's Room does not have signage indicating that assistive listening devices are available.		
	Code Section(s): 11B-219; 11B-216.10		
	Remedy: If no assistive listening devices are available, sets should be purchased, and employees trained on procedures for public use requests and operation. If assistive listening devices are already available, then signage should be installed.	Action Plan:	Completed:

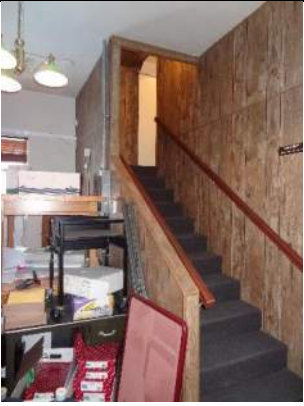
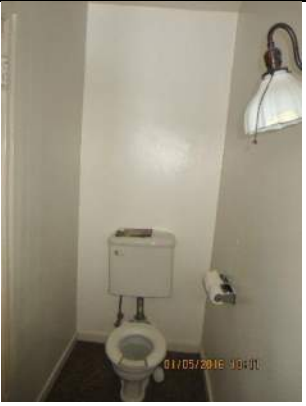
9.	<p>Issue: Building A, the Courthouse, Level 3 is not currently open to the public but has the following noted deficiencies that are included in this report for future planning purposes:</p> <ul style="list-style-type: none"> • Light fixture in corridor is less than 80" AFF and is a protruding hazard. • Corridor is only 43 ½" clear and may not be wide enough for an accessible route, depending on use and occupancy. • Law Library carpet has a pad, and large holes which prevent wheelchair users from accessing the room. • The toilet room is not accessible and would require a complete remodel. • The stairs up from the 2nd floor do not have compliant head clearance and there is no accessible route to this level.

<p>Code Section(s): 11B-307; 11B-403.5.1 exc. 2; 11B-302.2; 11B-206.2.3</p>		
	<p>Remedy: Addition of an accessible route, accessible toilet rooms, and replacement or modification of protruding hazards, floor materials, operable parts, and stairs should be made before this level is open to the public. This information is provided for planning purposes only.</p>	<p>Action Plan:</p>	<p>Completed:</p>

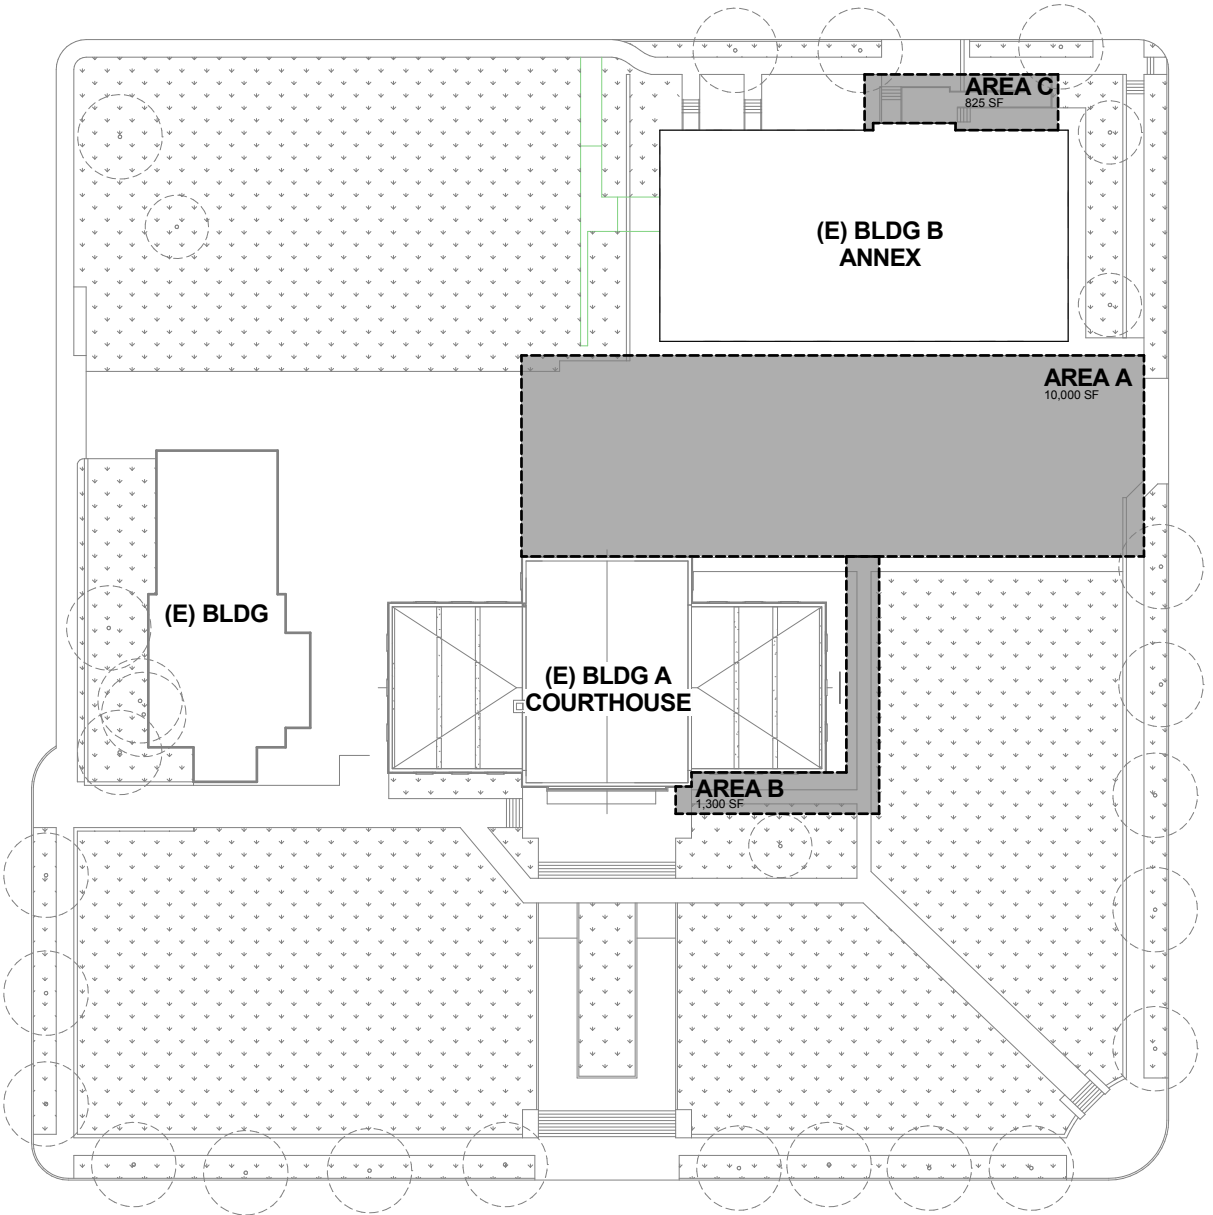
1 SITE PLAN
SCALE 1" = 20'-0"

1-2: EXISTING PAVING IS CRACKED AND IN A DETERIORATED STATE OF CONDITION. DESIGN NEW CONCRETE PAVED ACCESSIBLE PARKING SPACES INCLUDING SIGNAGE AND PATH OF TRAVEL TO ACCESSIBLE ROUTES TO COURTHOUSE AND ANNEX
1-4: TRANSITION FROM PARKING STALL TO WALKWAY REQUIRES DETECTABLE WARNING PAD. SEPARATION OF PEDESTRIAN AND VEHICLE ROUTES IS ALSO REQUIRED. THIS WILL BE INTEGRATED WITH THE REDESIGN OF THE ACCESSIBLE ON-SITE PARKING SPACES.

- THIS IS STRICTLY A MAINTENANCE PROJECT WITH ADJUSTMENT FOR SLOPES AS NEEDED TO PROVIDE ACCESSIBLE PARKING SPACES AND REDIRECT RUNOFF TO (E) STORM DRAIN INFRASTRUCTURE
- DOES NOT INCLUDE PARKING LOT LIGHTING
- DOES NOT INCLUDE MODIFICATION OF (E) STORM DRAINAGE
- DOES NOT INCLUDE LIGHTING SCOPE TO IDENTIFY EGRESS LIGHT LEVELS

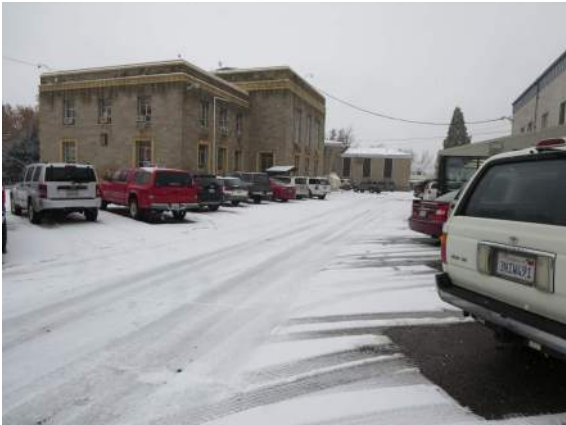
AREA B

1-11: WATER POOLS AT THIS LANDING. IT WILL NEED TO BE REDESIGNED TO SHED WATER PROPERLY. THIS MAY INCLUDE REDESIGN OF THE WALKWAYS LEADING TO THE LANDING.
1-12: EXCESSIVE RAMP SLOPES ARE NON-COMPLIANT; NO INTERMEDIATE LANDING. NON-COMPLIANT HANDRAILS. RAMP WILL NEED TO BE REDESIGNED.
1-13: CROSS SLOPES AT THE LANDING AT THE TOP OF MAIN ACCESS RAMP AND ALONG MAIN ENTRY ARE NOT IN COMPLIANCE. THESE AREAS WILL NEED TO BE INCLUDED IN THE REDESIGN OF THE MAIN ACCESS RAMP.

- ALTERNATIVE ENTRANCES WERE EXPLORED, BUT THERE ARE NO VIABLE ALTERNATIVES THAT WOULD MAINTAIN THE FUNCTIONALITY OF THE FLOOR PLAN
- DOES NOT INCLUDE REDESIGN OR REPLACEMENT OF ANY LANDSCAPING OR IRRIGATION
- DOES NOT INCLUDE LIGHTING SCOPE TO IDENTIFY EGRESS LIGHT LEVELS

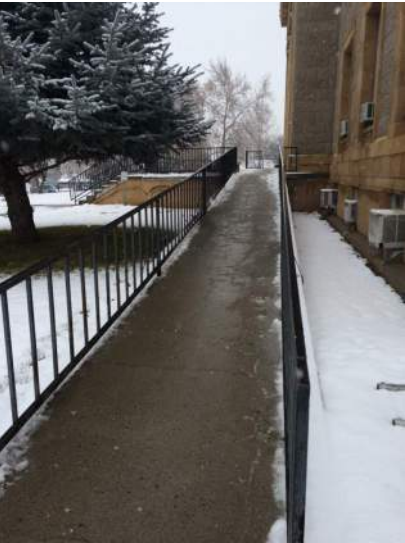
AREA C

1-15: EXCESSIVE RAMP SLOPES ARE NON-COMPLIANT; NON-COMPLIANT HANDRAILS. RAMP WILL NEED TO BE REDESIGNED.
1-16: STAIR REQUIRES COMPLIANT GUARD AND HANDRAILS, AND STRIPING FOR THE VISUALLY IMPAIRED.

- ALTERNATIVE ENTRANCES WERE EXPLORED, BUT THERE ARE NO VIABLE ALTERNATIVES THAT WOULD MAINTAIN THE FUNCTIONALITY OF THE FLOOR PLAN
- DOES NOT INCLUDE REDESIGN OR REPLACEMENT OF ANY LANDSCAPING OR IRRIGATION
- DOES NOT INCLUDE LIGHTING SCOPE TO IDENTIFY EGRESS LIGHT LEVELS
